Decay Detection in Red Oak Trees Using a Combination of Visual Inspection, Acoustic Testing, and Resistance Microdrilling

Xiping Wang and R. Bruce Allison

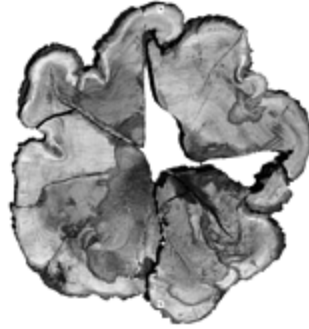
Figure 1. Comparison of acoustic tomographs and photographs of corresponding cross-sections for red oak tree No. 307.

times ranging from 1640 to 3248 $\mu\text{s}/\text{m}$ (500 to 990 $\mu\text{s}/\text{ft}$). These values were significantly higher than the anticipated transmission times for intact oak of 621 to 724 $\mu\text{s}/\text{m}$ (189 to 221 $\mu\text{s}/\text{ft}$) (Wang et al. 2004). The tomographs indicated a large area of defect at all three elevations. The Resistograph drilling revealed that some areas displayed in the tomographs as potential decay or cavity were actually sound wood and that large cracks were creating an acoustic shadow display in the tomograph.

After being cut down, tree No. 307 was found to have heartwood decay at all three elevations. Laboratory examination confirmed the presence of white rot decaying fungus. The decay was less severe in the upper cross-section (200 cm [80 in] elevation), but it increased in size as the elevation dropped.

In addition to decay, major internal cracks were present in the cross-sections of tree No. 307. The combination of extensive decay and large lateral cracks caused the base disk to fall into several pieces during transportation. The photographs of the disks show that lower and middle cross-sections had multiple lateral cracks and the upper cross-section had one large lateral crack.

Figure 1 shows the comparisons of acoustic tomographs and photographs of the cross-sections at three elevations for red oak No. 307. The dark-colored zones (brown if it is in color print) in the tomographs represent solid wood, and the light-colored zones represent potentially decayed wood (if displayed in color, the tomographs use green, violet, and blue to represent increasing degradation by decay). It is clear that the tomographs show a strong correspondence to the images of the disks. Extensive decay and radiating lateral cracks in the lower and middle cross-sections were reflected by large light-color zones in the tomographs. The tomograph of the upper cross-section accurately located the position and orientation of the big lateral crack and heartwood decay.

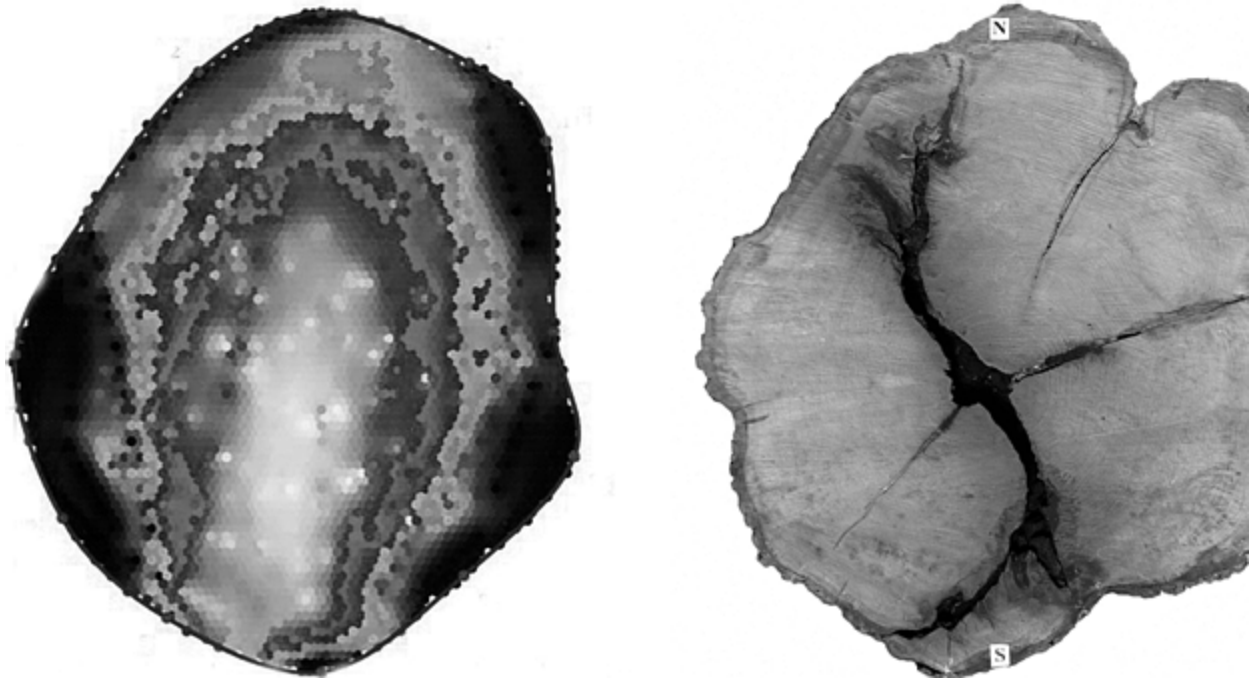
Figure 2. Comparison of acoustic tomograph and photograph of the cross-section for red oak tree No. 123.

For red oak No. 123, the visual inspection revealed trunk seams and cracks with cankering on the south side with associated *Ustulina deusta* fungus. The single-path stress wave tests revealed a stress wave transmission time ranging from 1908 to 2320 $\mu\text{s}/\text{m}$ (581 to 707 $\mu\text{s}/\text{ft}$). The tomography revealed a large area of defect. The Resistograph drilling revealed a large snake-shaped crack. Figure 2 shows the comparison of the acoustic tomograph and photograph of the cross-section for red oak No. 123.
